STRUCTURES TECHNICAL MEMORANDUM 397

FURTHER INVESTIGATIONS TO IMPROVE THE FATIGUE  
LIFE OF THE MIRAGE IIII WING MAIN SPAR

J.Y. MANN, A.S. MACHIN and W.F. LUPSON

JANUARY 1985

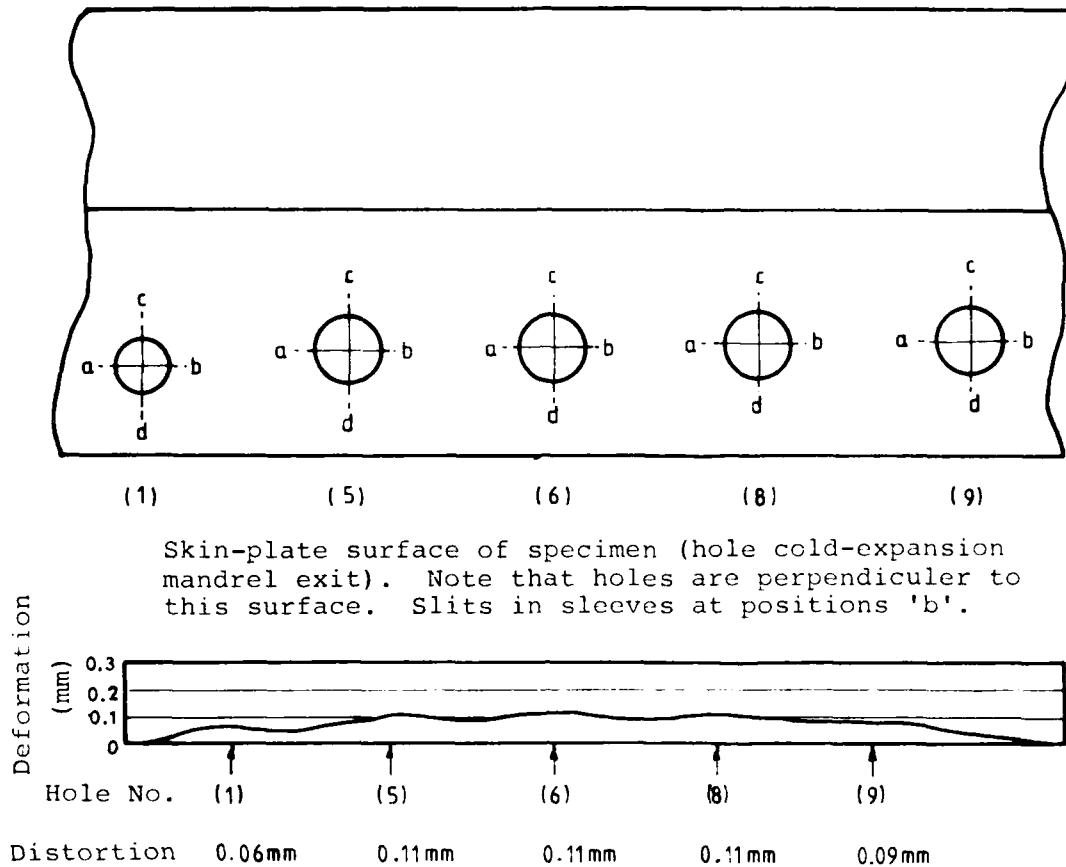
(a) Deformation at side of specimen adjacent to bolt holes

(b) Out-of-plane deformations at edges of holes

FIG. 5 DEFORMATIONS ASSOCIATED WITH COLD-EXPANSION OF HOLES (SPECIMEN NO. GZ1B12)

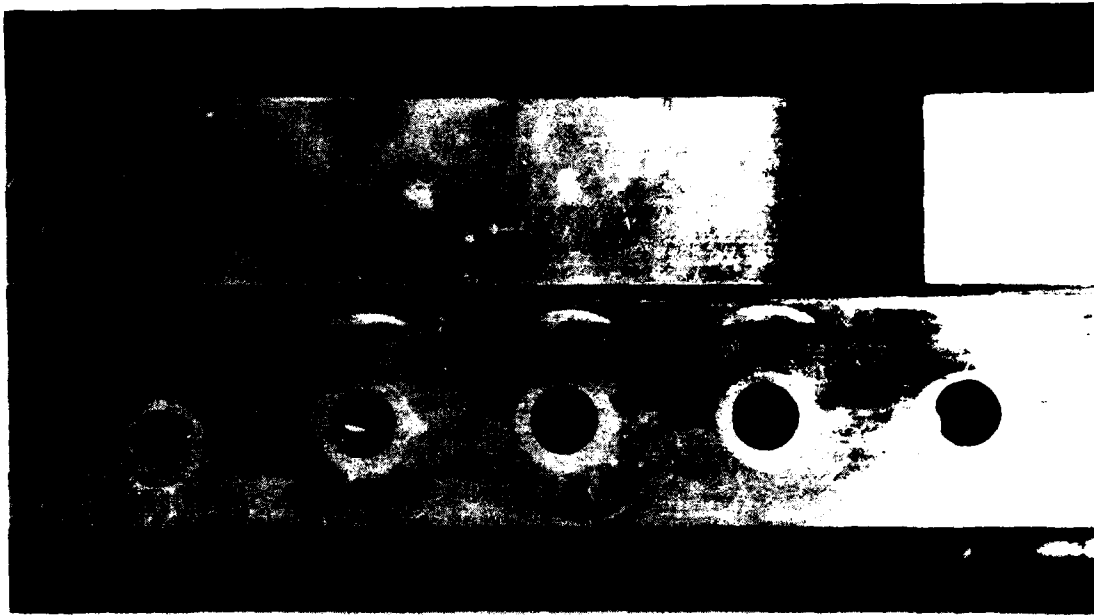
FIG. 6 SPECIMEN GZ1B12. EXTENT OF SURFACE DEFORMATION ON  
SKIN-PLATE SURFACE AROUND COLD-EXPANDED HOLES

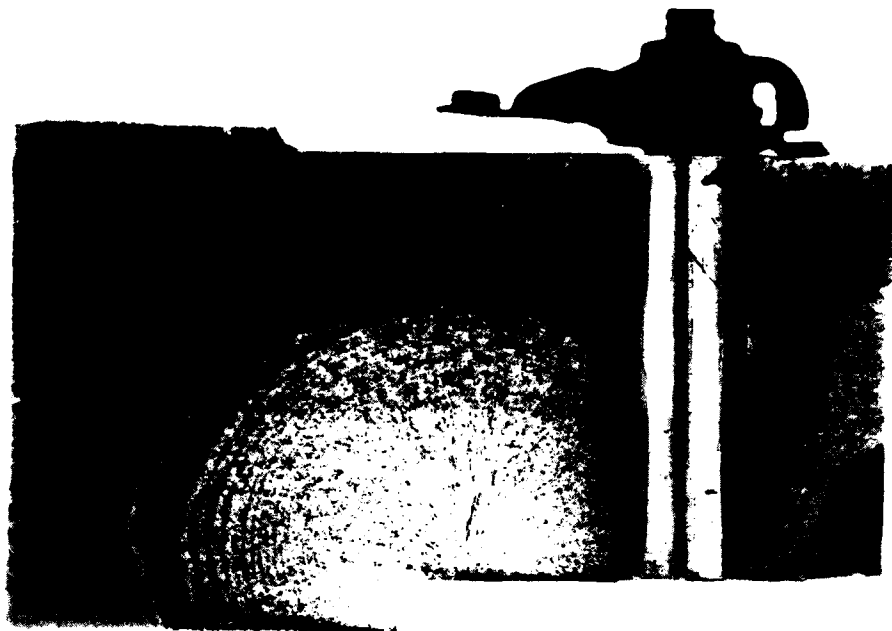
(e) Group C: Redesigned spar with cold-expanded bolt hole, GZ1B3 (Failure at hole (5))
